Hose Reel Washdown Systems

Wicking Problems Technical Note

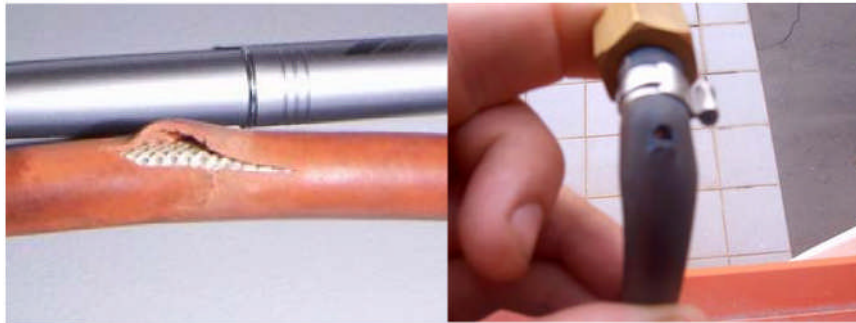
“Wicking” this is when the inner tube of the hose is pierced allowing the gas or fluid to then run through and around the braiding until it finds a weak spot in the outer tube and bubbles up or blows out. Although wicking can occur in all manner of hoses it is more common on softer compounded hoses like small bore rubber hoses used for Oxygen and Acetylene, Propane etc.

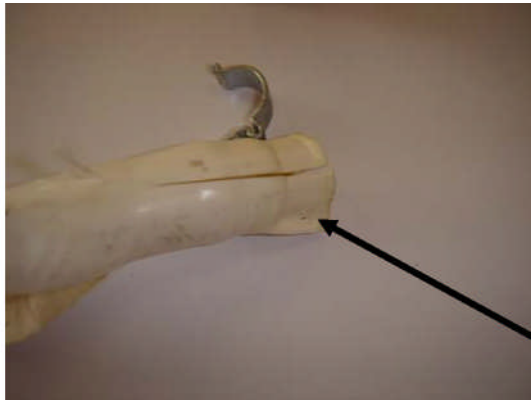
In this case the use of a twin eared clamp has crushed and pinched the outer tube of the hose.

See just to the left of the arrow a small hole.

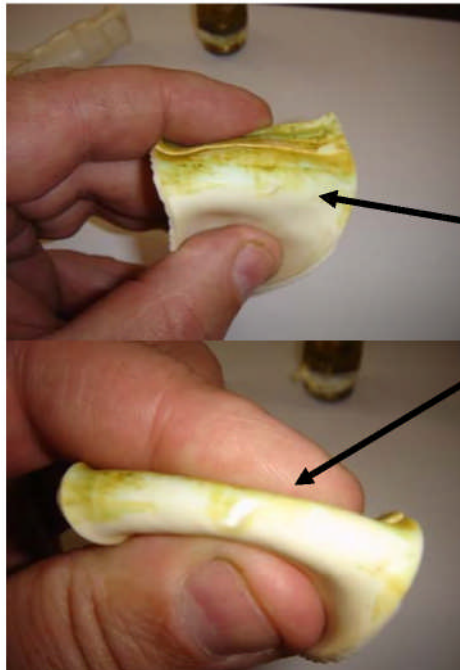
Typical wicking mark, the barb has been forced through the inner tube allowing product to flow between the outer and inner tubes.

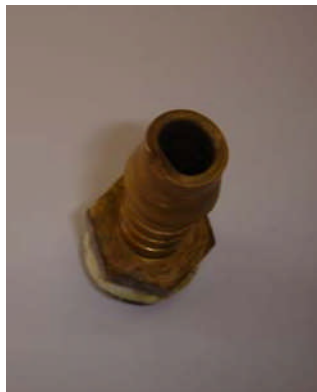
In this case the damaged and dented barb shows there has been severe impact crushing down through the hose onto the barb. The edge of the barb is forced through the inner tube causing wicking issues.
